EVALUATION OF ANODES FOR GALVANIC CATHODIC PREVENTION OF STEEL CORROSION IN PRESTRESSED CONCRETE PILES IN MARINE ENVIRONMENTS IN VIRGINIA

July 1999 VTRC 00-R3

Five anode systems were tested on several piles of the Willoughby Bay Bridge on I-64 in Norfolk, Virginia: (1) an aluminum-zinc-indium alloy applied by arc-spraying on the concrete, (2) a zinc foil with conductive adhesive backing, (3) a system of zinc mesh and grout jacket, (4) a system of zinc mesh and compression panels, and (5) a bulk zinc. During the first 14 months of operation, the protection current outputs of these anodes, the closed-circuit potentials of the steel at various elevations on the piles, and the extent of polarization imparted were measured. Attempts to project the life of these anodes and compare the costs of using them were also made.

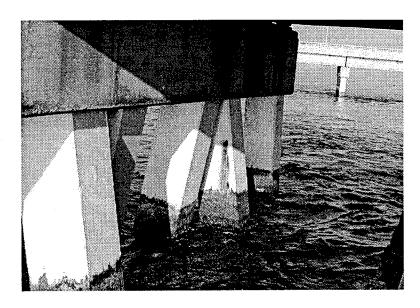
Figure 1. Concrete Piles in the Hampton Area with Visible Signs of Steel Corrosion

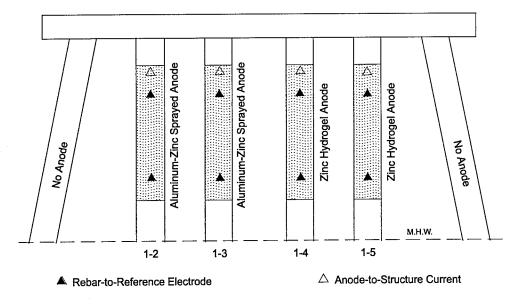
Figure 2. Placement of Anode and Test Electrode for Bent 1

Since funding was limited, only 10 test piles were selected for this investigation. These square prestressed concrete piles are part of two of the hundreds of bents that support the I-64 bridge over the Willoughby Bay in Norfolk, Virginia. To facilitate understanding of the behavior of the different anodes, the anodes, either alone or in combination, were assigned as indicated in Table 1 and shown on the plans in Figures 2 and 3.

This anode was applied to piles 1-2, 1-3, 2-1, 2-5, and 2-6 over the concrete areas designated in Figures 2 and 3. The material used was a cored wire, 3.18 mm (0.125 in) in diameter. The outer sheath of this wire was a relatively pure aluminum alloy, and the core contained aluminum, zinc, and indium powder of sufficient composition to yield a final anode composition of 80 percent Al, 20 percent Zn, and 0.2 percent In.^{4,5}

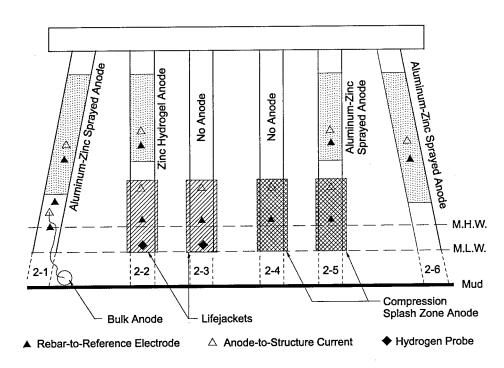
Figure 3. Placement of Anode and Electrode for Bent 2

A 22.7-kg (50-lb) zinc bulk anode was added to determine how much of the concrete above the waterline can be protected by a bulk anode. As illustrated in Figure 3, this anode was immersed at 0.9 m (3 ft) below the level of the water at low tide and attached to the reinforcing steel of pile 2-1.

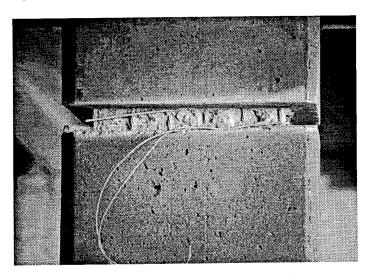
Figure 4. Establishment of Contacts to Steel Tendons at Top of Each Pile. The entire channel was arc-sprayed with Al-Zn-In.

pile was cut at the top of each pile to expose the tendons (Figure 4). Testing of the exposed tendons revealed that about 20 percent of the tendons in each pile were not electrically continuous, even though each pile had a spiral wire wrapped around each tendon. Therefore, all exposed tendons within the channel were arc-sprayed with the Al-Zn-In alloy to establish electrical continuity. Afterward, negative return and test wires were attached to the spiral wire by brazing and then run through PVC conduit to the main terminal box. The channel was then filled with sand-filled epoxy (Pilgrim EM-52Gel) flush with the surface of the pile.

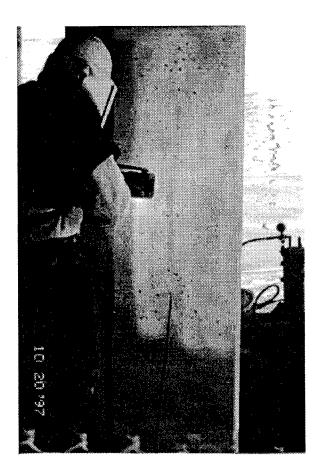
Figure 5. Arc Spraying of Al-Zn-In Anode on One Concrete Pile

The anode was applied to the cleaned and dry surface of the concrete piles using the arcspray metallizing technique (Figure 5). This technique involved continuously feeding the wire through a hand-held arc gun. When the wire reached the tip of the gun, a high-voltage arc vaporized the wire, and the vapor was then instantaneously sprayed on the concrete with a jet of compressed air coming out of the tip. The vapor then condensed on the surface of the concrete to form a continuous metallic coating. Figure 6 shows a completed Al-Zn-In anode on two piles. The alloy anode was applied to a thickness of 300 microns (12 mils), which was determined by measuring the thickness of the coating applied to tapes that were attached to the pile at selected locations. Alloy consumption was about 0.537 kg/m² (0.11 lb/ft²) at an application rate of 0.557 m²/min (6 ft²/min). The target adhesion was 1.0 MPa, with 0.3 MPa as minimum. The actual adhesion, as measured with an Elcometer adhesion tester, ranged from 0.7 to 2.4 MPa.

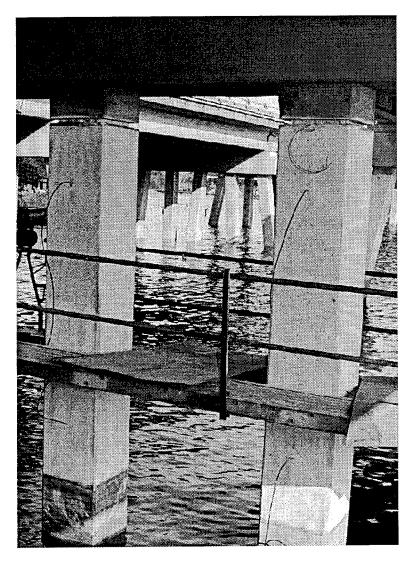
Figure 6. Arc-Sprayed Al-Zn-In Anode in Piles 1-2 and 1-3. Notice the black lead wires or the reference electrodes extending out from the concrete at the splash zone and the top of each pile. Notice also the ground (negative) connection to the steel at the top of each pile.

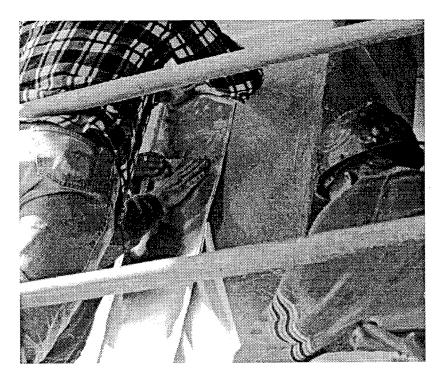
Figure 7. Installation of Zn/Hydrogel Anode, Starting From Top of Concrete Pile

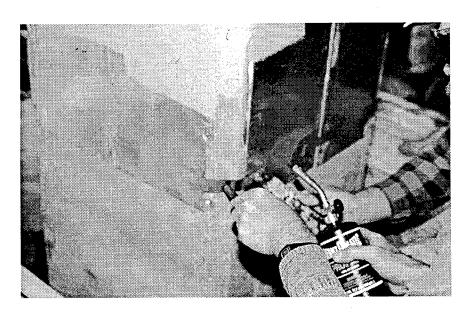
Figure 8. Installation of Zn/Hydrogel Anode on Pile 1-5, Showing Caulking Being Applied Between Zinc Foils Attached on One Face of Pile

Two strips were attached to each side of each designated pile (Figure 8). The strips were not overlapped. Each strip was made electrically continuous by soldering a 25 by 50 mm (1 by 2 in) zinc strip across adjacent strips at the top and bottom of each joint (Figure 9). The joints between strips and at the top and bottom of each strip were sealed with a silicone acrylic caulk, and the entire surface was coated with a moisture-cured polyurethane (Wasser Hi-Tech MC-

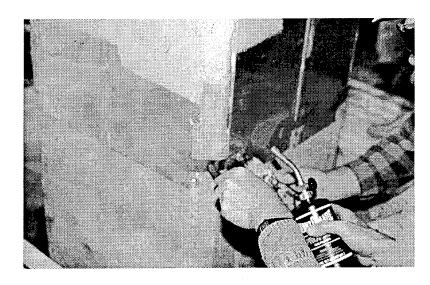
Figure 9. Establishment of Electrical Connection Between Adjacent Sections of Zn/Hydrogel Anode by Soldering Connecting Bands of Zinc on Sections

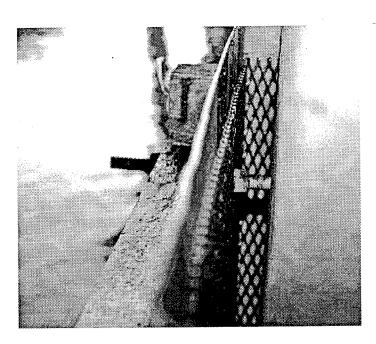
Figure 11. View From Top of Jacket Installed Around Pile Before Pumping of Grout. Notice the expanded zinc mesh being held in place by one of the standoff studs.

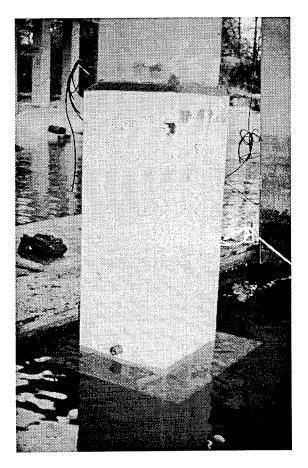
Figure 12. Completed Zn/Grout Jacket Anode. Notice that the grout was beveled at the top and that the filling portal at the bottom of the jacket is visible during low tide.

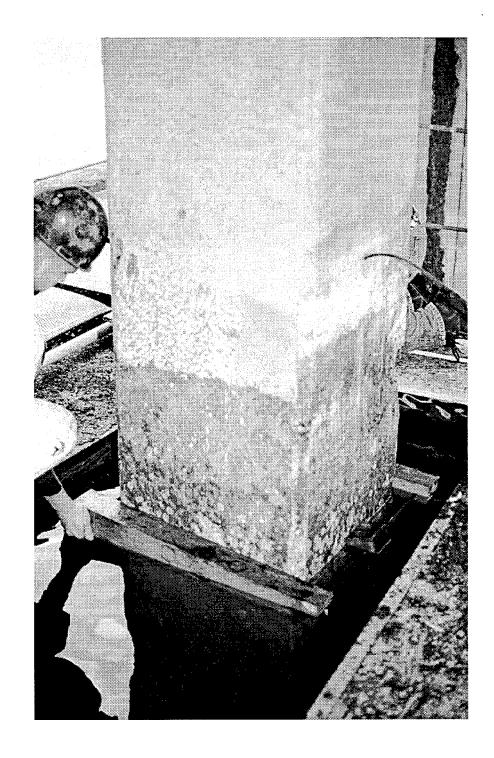
Figure 13. Preparation for Installation of Zn/Compressed Panel Anode During Low Tide. Notice the reference electrode lead wire extending from inside the concrete on the right side of the pile.

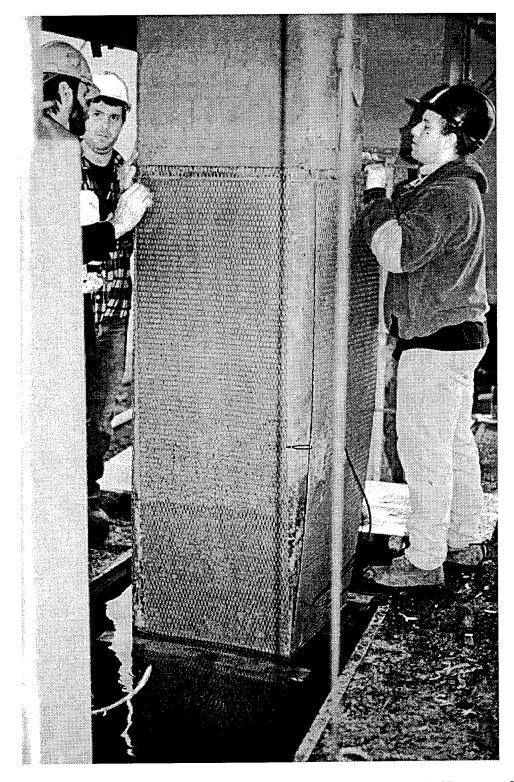
Figure 14. Workers Securing Four Panels of Expanded Zinc Mesh Around Pile for Zn/Compressed Panel Anode. Notice the long strip of zinc that connects all the panels at the top.

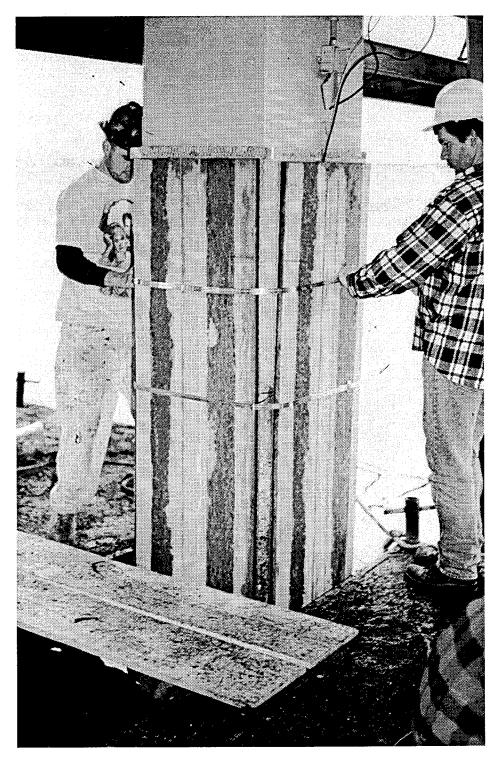
Figure 15. Zinc Mesh/Compression Panel Anode System Being Secured Around Pile with Stainless Steel Bands. Portions of the expanded zinc mesh are noticeable at the top of the panels and between panels. Notice the lead wires from the connection to the zinc mesh and a reference electrode, which are routed through the junction box and the PVC conduit to the main terminal box.

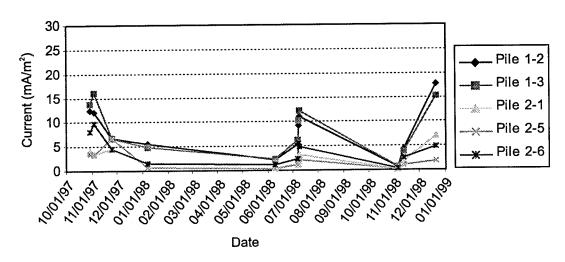
Figure 16. Current Outputs of Al-Zn-In Anode on Different Concrete Piles

The average current outputs of the Al-Zn-In anode were the lowest, ranging between 2.0 and 8.4 mA/m², depending on the piles. These were considerably lower than those reported in an earlier FHWA study by almost an order of magnitude. This large difference was noticed immediately after the activation of the anode systems and prompted an investigation to identify the cause. By chemical analysis, using atomic absorption spectroscopy, we discovered that the outer sheath of the Al-Zn-In alloyed wires used by the contractor contained approximately 400 ppm of copper. This amount of copper was apparently sufficient to poison any sacrificial aluminum-alloy anode and, therefore, decreased its current output significantly. Early data from an installation of this same anode on concrete piers in Quebec, Canada, completed in late 1998 indicated that their current outputs were, so far, comparable to those reported in the FHWA study. It has been suggested that the copper content of an aluminum anode should be restricted to perhaps no more than 50 to 100 ppm. The applicability of this restriction to the alloy wire to be used for the arc-spraying of Al-Zn-In anodes needs to be investigated.

It is not known why the current outputs of the Al-Zn-In anode on piles 2-1, 2-5, and 2-6 were considerably lower than on piles 1-2 and 1-3. Since the former piles belonged to the same bent, inconsistency in application of the anode on the piles may be a factor. Examination of the noted tide level during the day and time the measurements were made indicated that this factor, and possible humidity and temperature, too, had some influence on the current output of this anode, with current output being lower during low tide. This is not unexpected, since these factors can affect the electrical conductivity of any concrete. In fact, the earlier FHWA study also reported that surrounding environmental conditions caused the magnitude of galvanic current from this anode to vary significantly with time.

Figures 16 to 20 illustrate the fluctuations in the average current outputs of the five anodes during the first 14 months of operation. It is clear that the current outputs of the

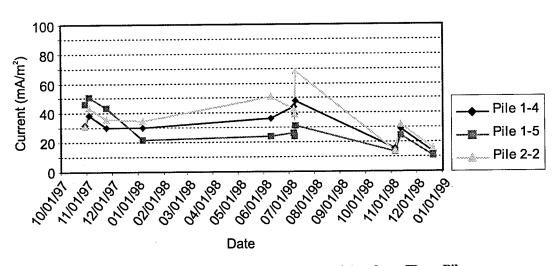
Figure 17. Current Outputs of Zn-Hydrogel Anode on Three Piles

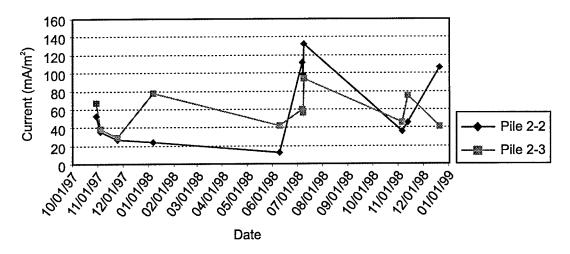
Figure 18. Current Outputs of Zn-Grout Jacket Anode System on Two Piles

Zn/compressed panel and the bulk Zn anodes had decreased considerably within the first 30 to 60 days of operation. Of the three anodes used in the tidal and the splash zones, these two have one commonality: their active element, the zinc, is the most exposed to the seawater. In the case of the bulk zinc anode, it was constantly submerged, whereas in the case of Zn/compressed panel, the exposed portion of the expanded zinc mesh comes into contact with the seawater

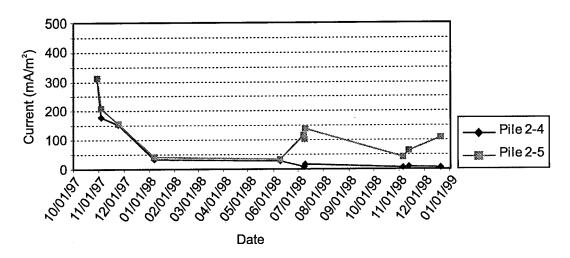
Figure 19. Current Outputs of Zn-Compressed Panel Anode System on Two Piles

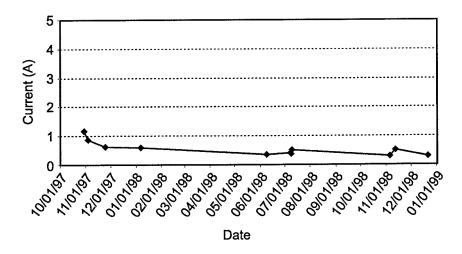
Figure 20. Current Output of Submerged Bulk Zn Anode on Pile 2-1

during high tide. When the zinc comes into contact with the seawater, it can discharge a high amount of current, much to the seawater, until sufficient oxide is built up over its exposed surface to hinder current flow in that area. This may explain the large drop in the current outputs of these two anodes in the first 30 to 60 days of operation. It appeared that the current outputs of the Zn/hydrogel anodes showed a similar decreasing trend, although to a lesser extent.

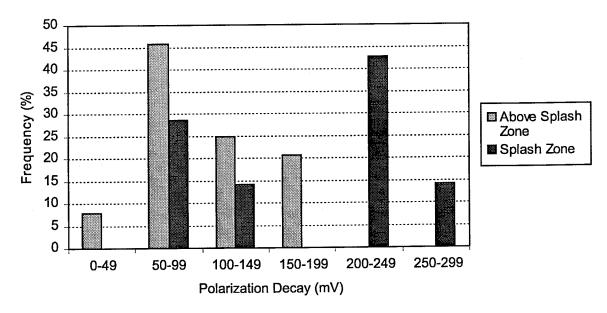
Figure 21. Frequency Distribution of Polarization Decays with Al-Zn-In Anodes at Different Elevations

Table 5 presents a summary of the extent of polarization decay at different elevations on the piles, and Figures 21 to 25 are graphic presentations of the frequency distributions. The polarization decay on the piles with the Al-Zn-In anode varied, in general, with tide level and elevation on the piles. Likewise, as Figure 21 shows, the extent of polarization decay above the splash zone was less than at the splash zone. Above the splash zone, where corrosion is likely to be less severe, during approximately 54 percent of the time, polarization decay did not reach the 100-mV criterion for adequate protection. This means that if 100-mV depolarization is necessary, the section of steel tendons above the splash zones in the piles with the Al-Zn-In was not protected 54 percent of the time. At the splash zone, where corrosion would be relatively more severe, the polarization decay was less than 100 mV in only 29 percent of the observations.

Because of the logarithmic relationship between applied current and potential, the polarization decay in this investigation for the Al-Zn-In anodes did not suffer proportionally, even though the current outputs from these anodes were as much as an order of magnitude lower than those from the same anode tested in the earlier FHWA study. In contrast to the polarization decay of 82 to 318 mV reported in the FHWA study, those in this project ranged between 52 and 221 mV.

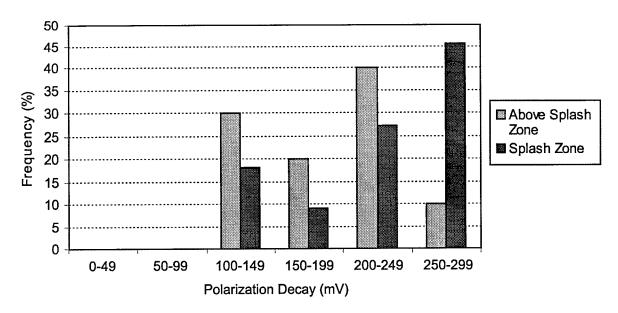
Figure 22. Frequency Distribution of Polarization Decays with Zn/Hydrogel Anodes at Different Elevations

Among the anodes tested, the Zn/hydrogel anode provided the strongest protection to the steel both at the splash zone and above. As evident in Figure 22, the polarization decay exceeded the 100-mV criterion 100 percent of the time. The polarization decay was also relatively more uniform at both pile elevations, which is perhaps an indication of the relatively uniformity of its current outputs. And, as with the Al-Zn-In anode, the polarization decay for this anode varied in accordance to elevations on the piles, higher where it is necessary, i.e., the splash zone.

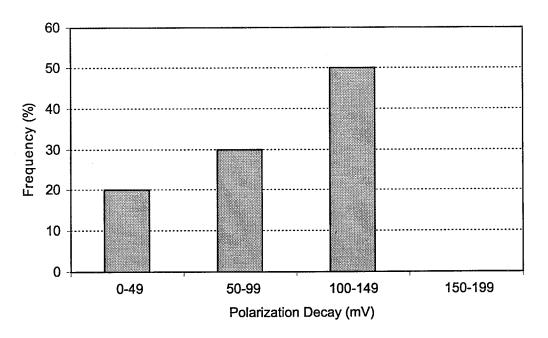
Figure 23. Frequency Distribution of Polarization Decays with Zn-Grout Jacket Anodes at Tidal and Splash Zones

As described earlier, the Zn/grout jacket anode and the Zn/compressed panel anode are designed to be installed around piles at the tidal to the splash zone, where corrosion is expected to be relatively more severe. However, as Figure 23 shows, the Zn/grout jacket anodes provided polarization decay greater than 100 mV in only 50 percent of the observations, with a mean of 88 mV. Most of the polarization decay less than the 100-mV criterion was on pile 2-2. Perhaps this is an indication that this particular system was not installed properly.

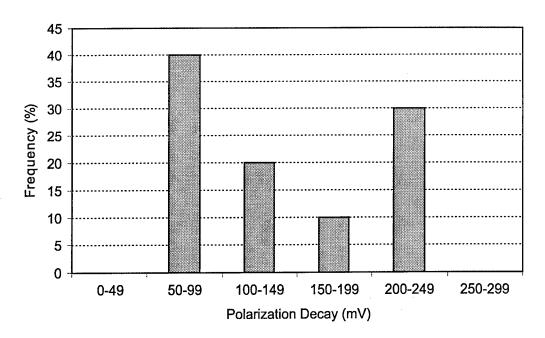
Figure 24. Frequency Distribution of Polarization Decays with Zn-Compressed Panel Anodes at Tidal and Splash Zones

In contrast, the Zn/compressed panel anodes provided slightly stronger protection, with more than 100-mV polarization decay in 60 percent of the observations and a mean polarization decay of 133 mV (Figure 24). As expected, this difference in the polarization decay achieved by the Zn/grout jackets and the Zn/compressed panels can be accounted for by the difference in their current outputs. As Table 2 indicates, the ratio between the average current output of the Zn/compressed panels over that of the Zn/grout jackets is approximately 1.6. This is comparable to the ratio of 1.5 for the corresponding average polarization decay for these two anodes, i.e., 133 mV/88 mV.

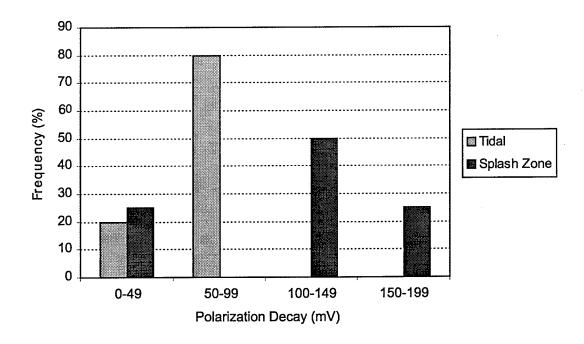
Figure 25. Frequency Distribution of Polarization Decays with Submerged Bulk Zn Anode at Tidal and Splash Zones of Pile 2-1

Figure 25 indicated that the submerged bulk Zn anode attached to pile 2-1 failed to provide sufficient polarization to the steel at the tidal zone to exceed the 100-mV criterion. However, at the slightly higher elevation of the splash zone, with current contributed by both the bulk Zn anode and the Al-Zn-In anode sprayed above this zone, the achieved polarization decay was slightly higher, with only 25 percent of the observations below the 100-mV criterion.
